How to stop brake reservoir cap leakage:

How to stop brake reservoir leakage in a C5 Corvette

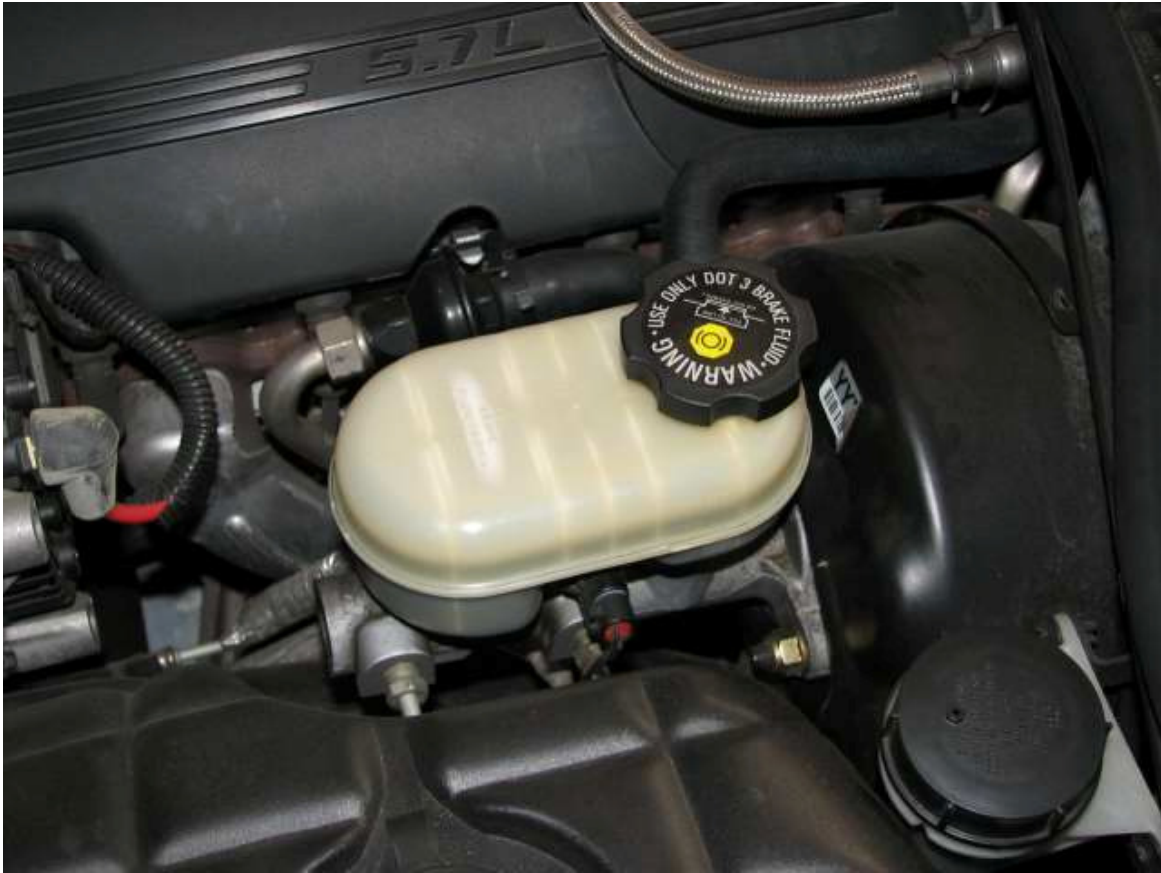
From the time my 01 coupe was new, its brake reservoir cover has seeped brake fluid. If I didn't wipe off the cover's lip periodically, fluid could run down and if nothing else, eat away at my painted garage floor.

Well, here's a fix that costs only a few bucks and a few minutes.

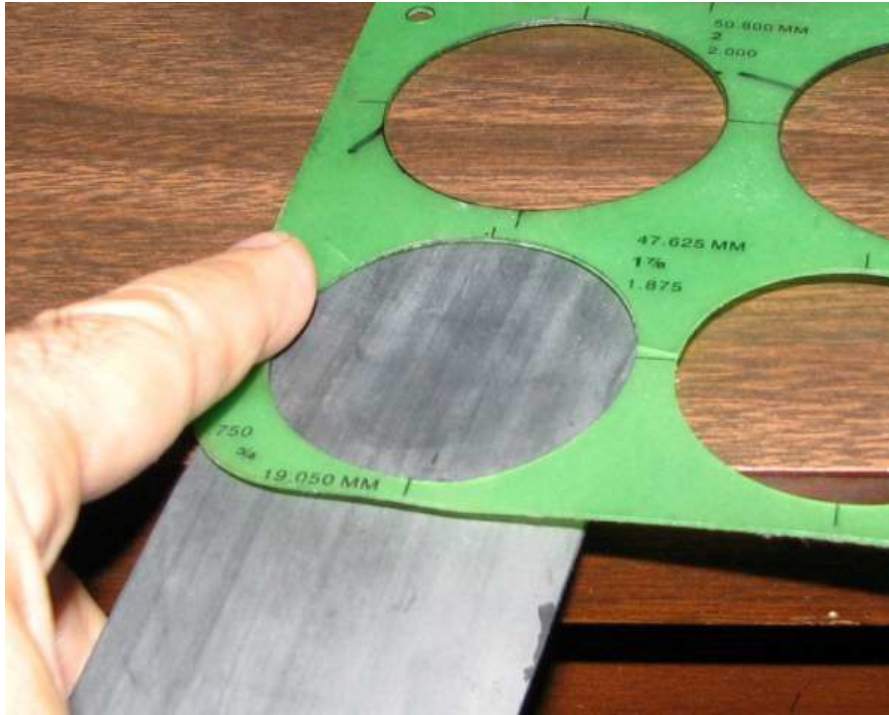
2. Next, cut a 1.88 –inch diameter circle. I used an old circle template.

1. Get ahold of some 1/32-inch thick x 2-inch wide x 36 inch long EPDM rubber strip - part number 8990K11 (www.mcmaster.com) at \$1.45. This material is very resistant to brake fluid. Don't use any other type of rubber without researching its compatibility to brake fluid.

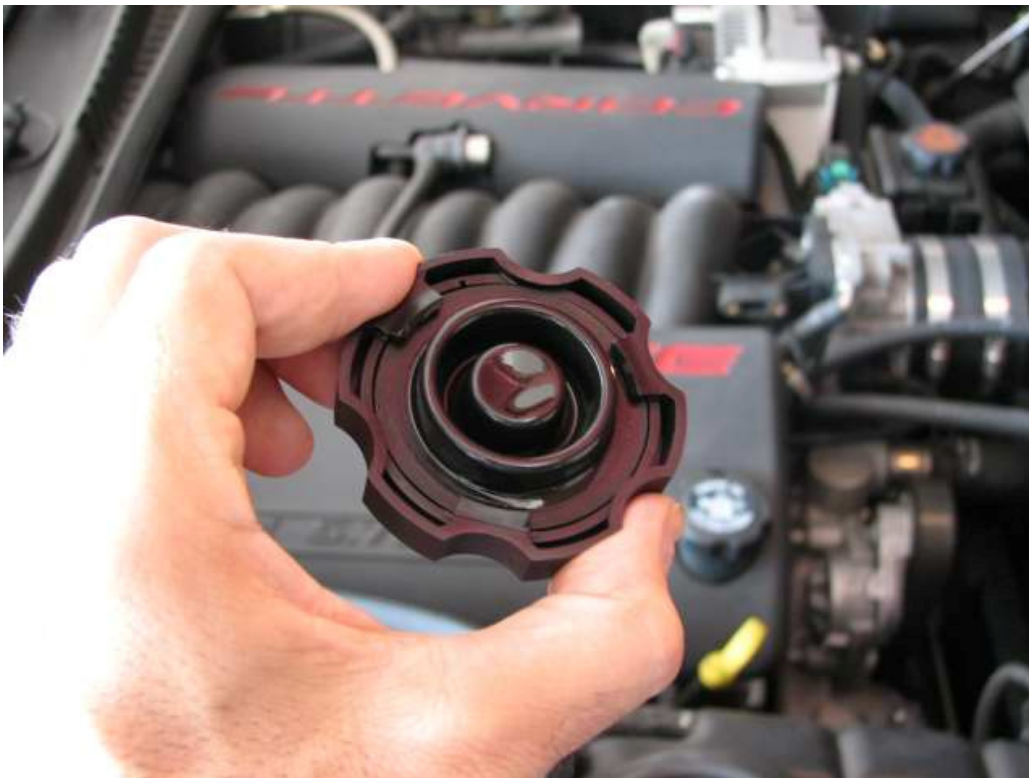
3. While wearing protective gloves (not shown), remove the reservoir cap.

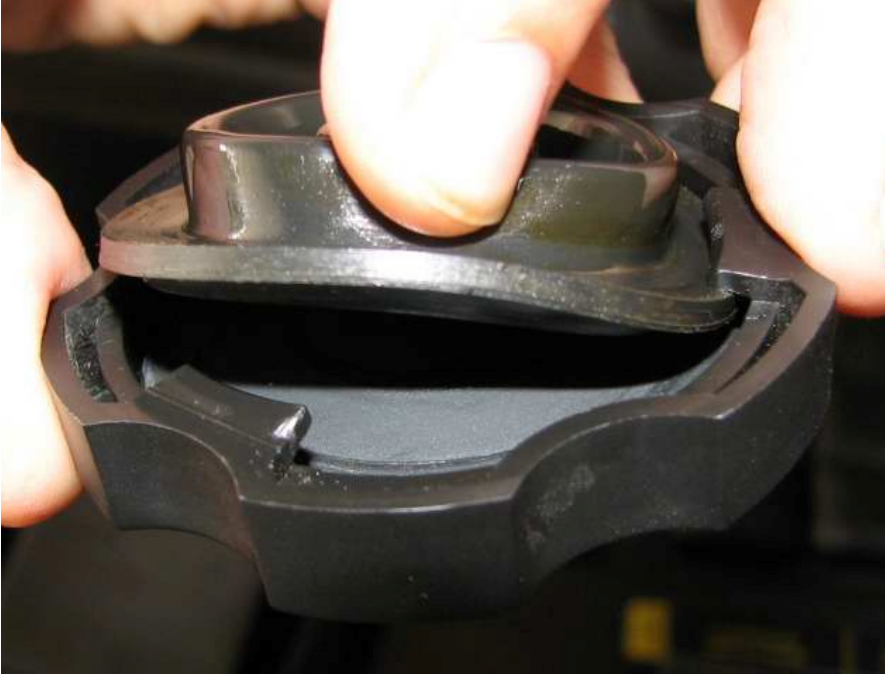
4. Remove the boot by squeezing and pulling it up.

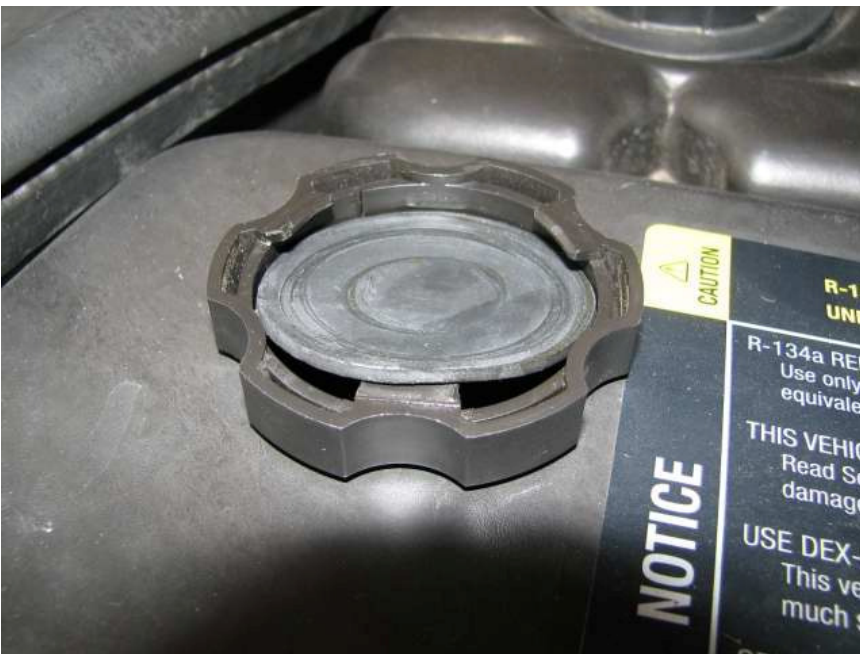
5. Install the new disc.

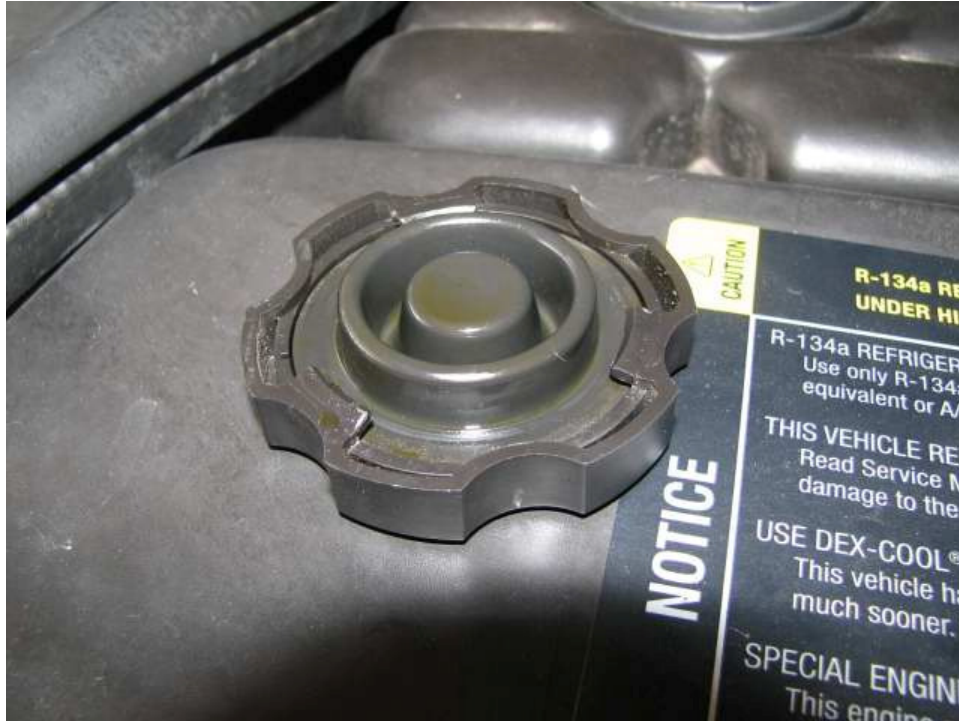
6. Reinstall the boot and replace the cap.

7. Your shimmed cap is now ready to be installed. You now have one less thing to worry about!
